Water intrusion at fittings and teak deck

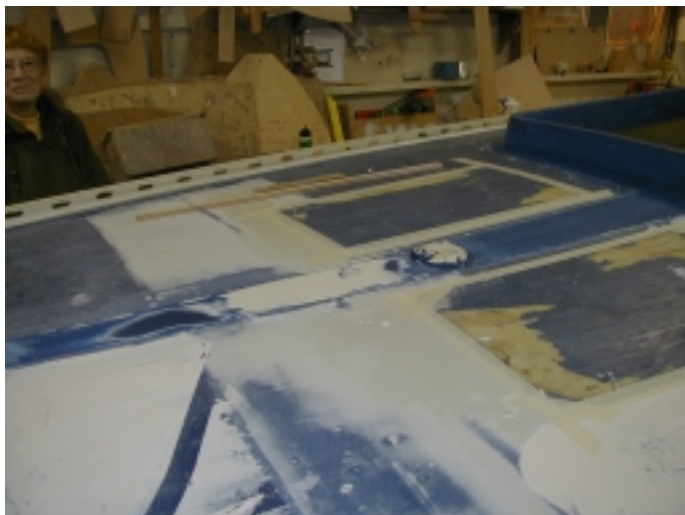
It is not without consequences if the teak deck is worn down such that the gel coat becomes visible. Screws fasten the teak during the gluing which leaves some holes that are tightened by wooden pins before Sikaflex covers it. When the teak is worn down it may happen that the water can

access the balsa wood in the sandwich construction. If counter actions are not taken the water will after some years ruin (rotten) the balsa wood and the deck will be soft as rubber. By knocking with the shaft of a screwdriver it is easy to locate the areas of the deck where the balsa wood is gone

Before a new teak deck can be laid down it is therefore often necessary to cut up the deck those places to repair the damages. So therefore: If your teak deck is worn down then make sure that the old screw holes are sealed off as quickly as possible. Check also with regular intervals all places

where screws and other fittings are mounted for leaks: at mast foot, garage door, jib/Genoa tracks, winches (screws and shaft), all fittings on the roof, the aft doors (in deck), head stay beam, fitting for flag mount and outboard engine fitting on deck if present. If you do not do anything it could be rather expensive!
